# Manhole Inspection Summary

Manhole # S33I\_\_022MH

Insp Date: **3/26/08 1:32 PM**

**Location** Address: **100 lombard**

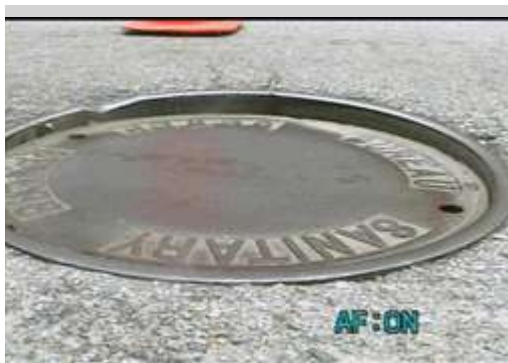
Defect 6

Comments **one side of the cover is 2" inside manhole**

Diameter: **26** (in.) Length: **0** (in.) Dist A/B Grade: **-2** (in.)

cover 2" below grade on one side

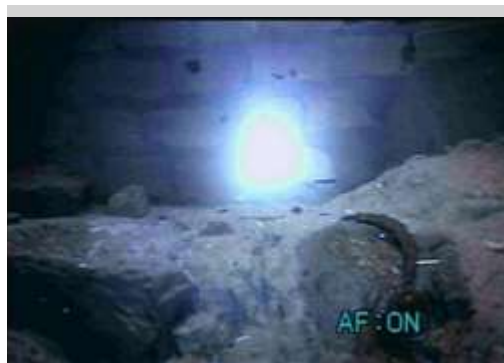
Defect 5

Condition: ☐ Sound ☐ Cracked ☐ Root Intrusion ☐ Deteriorated ☐ Leaks ☒ **Debris**

bench debris

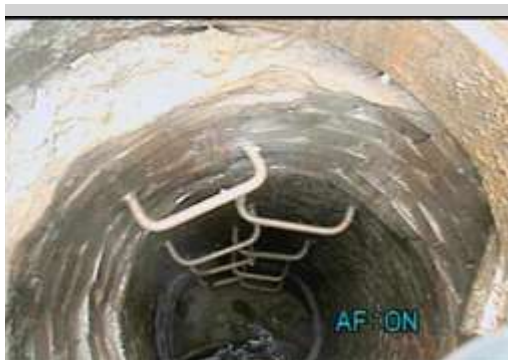
Defect 4

Count: **8** Missing: **0** ☒ **Corroded**

corroded steps

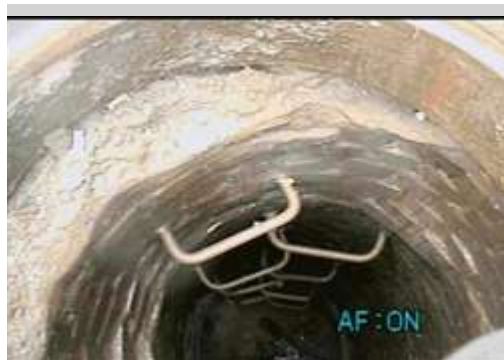
Defect 3

Condition: ☐ Sound ☒ **Cracked** ☐ Root Intrusion ☐ Loose Brick ☒ **Deteriorated**

cracked deteriorated chimney frame  
adjustment

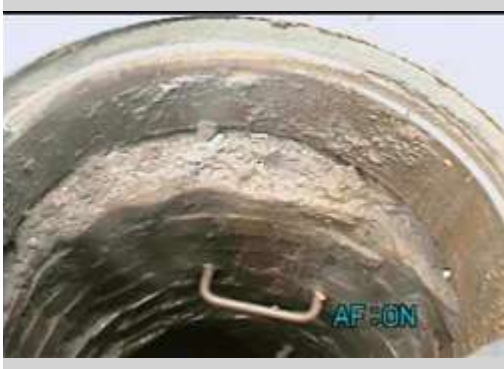
Defect 2

Offset: **4** (in.)

horizontal offset

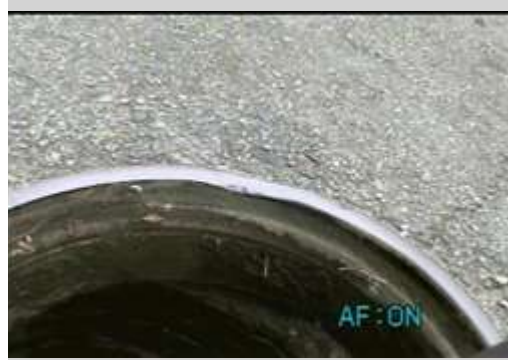
offset vertical frame on the side where the cover is low

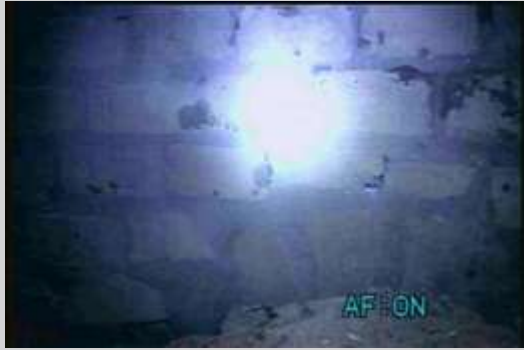
8 O'Clock Inflow

Pipe at 8(bottom right of pic) is filled in with a mound of dirt. Couldnt get infront of it for a better picture
